Dilution of Dynasolve 750 Solvent for Solvent Test Improvements

Neckodemos Davison, Cheng-Hsun Lee, Stephen E. Sadow, and Yung-Hsiao Chung

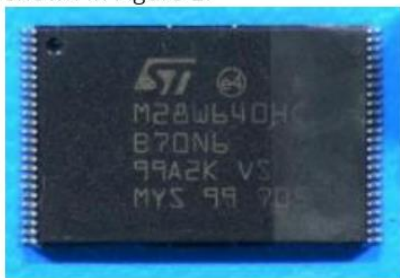
Figure 1. Authentic IC component that has undergone the standard Dynasolve 750 test at Global Electronic Testing Services-USA. The left section represents the package before testing and the right section represents the package after testing. The original manufactured package has been damaged and this is one example of hundreds.

exist for identifying counterfeit IC components such as visual, electrical, X-ray inspection (structural), XRF (chemical), solder wettability, and destructive. The study presented in this paper specifically focuses on heated solvent tests (HST) that fall under the category of destructive testing. HST utilize various organic chemicals in mixed solutions, or in high purity, to confirm that the outer package of an IC component is the original, robust polymer casing it was manufactured with. This process works very well at determining fake casings because of the poor quality paints typically used by the counterfeit industry. At Global ETS-USA, the two standard HST's use Dynasolve 750 and 1-methyl-2-pyrrolidinone. The Dynasolve 750 test requires the solvent to be heated to 105°C and the IC component to be submerged for 40 minutes. The 1-methyl-2-pyrrolidinone test requires the solvent used to be heated to 115°C and the IC component to be submerged for 2 minutes. Both tests are then concluded with a standard cotton swabbing of 5 wipes in one direction and then 5 wipes in the opposite direction. After years of conducting these tests for many clients, inspectors have observed that the 1-methyl-2-pyrrolidinone barely damages both real and fake components, but the Dynasolve significantly damages fake components and moderately damages real ones. The fact that Dynasolve damages real IC packages can be problematic when working with clients that want their pieces to be completely unscathed after passing the test. This study serves to provide a solution to this issue that is shown in Figure 1.
